Manhole Inspection Summary

Manhole # S41E__017MH

Insp Date: **3/10/09 2:44 PM**

Location Address: **1300 block of E FAYETTE ST** Cross Street: **N CENTRAL AV**

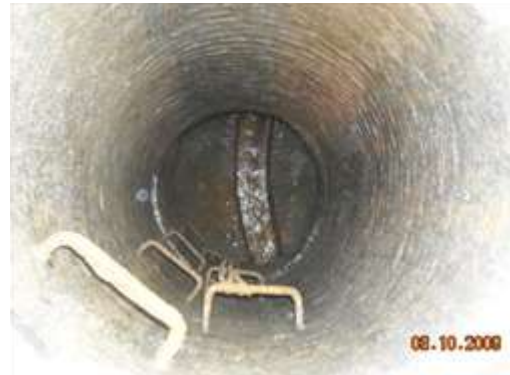
Top View

MH Continues Past Circular Corbel Wall

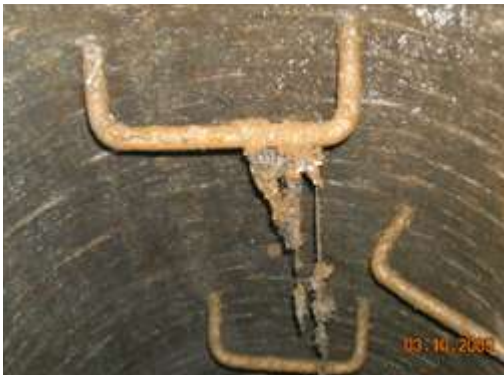
Defect 3

Infiltration: ☐ None ☒ **Joint** ☐ Cracks ☐ Mortar ☐ Roots ☒ **Wall**

Surcharge ☒ **Evidence Of Surcharge** Depth: **8** (ft.) ☐ Active Surcharge Present

SURCHARGE EVIDENCE, CORBEL INFILTRATION

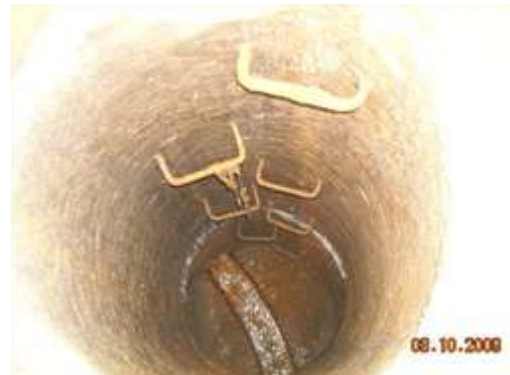
Defect 2

Steps Count: **7** Missing: **0** ☒ **Corroded**

CORRODED STEPS

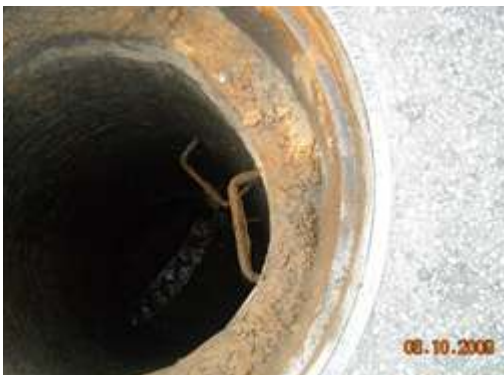
Defect 1

Frame Offset: **4** (in.) Condition: ☐ Sound ☐ Cracked ☒ **Leaks**

FRAME OFFSET

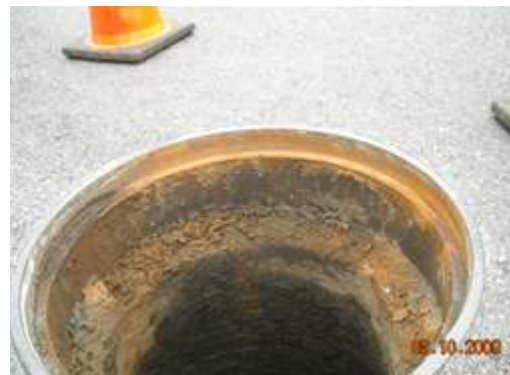
Defect 4

INFLOW EVIDENCE FROM SHEETING, DETERIORATING FRAME ADJ, JOINT INFILTRATION

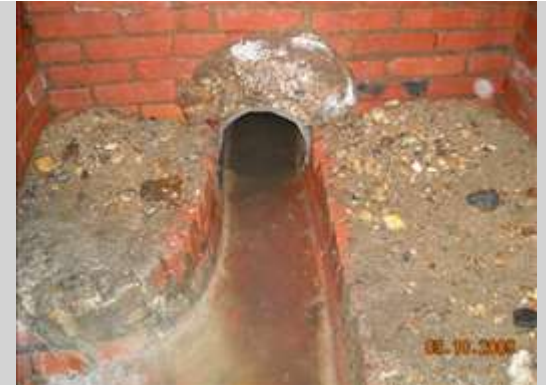
12 O'Clock Outflow

Infiltration: **Evidence** Pipe Seal Cond: **Sound**

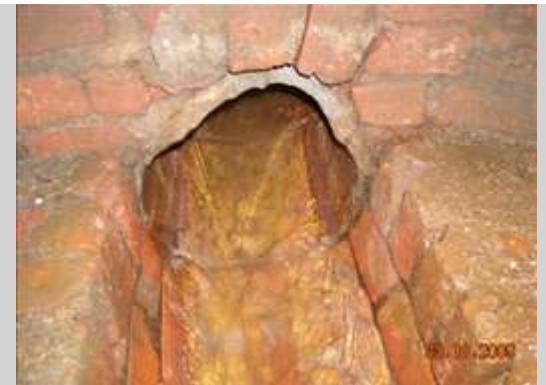
5 O'Clock Inflow

Infiltration: **None** Pipe Seal Cond: **Broken**

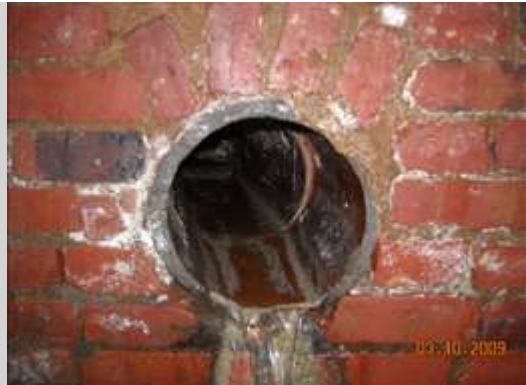
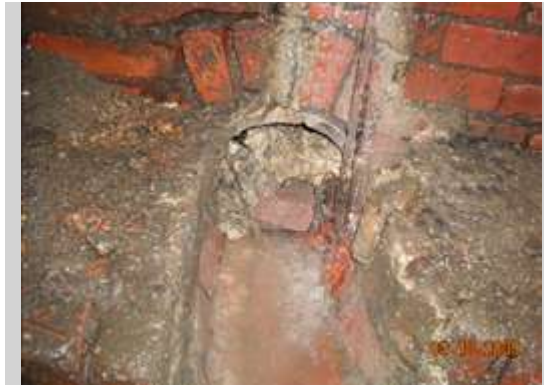
9 O'Clock Inflow

Drop Condition: **Clogged**
